Repair of a fractured implant overdenture gold bar: A clinical and laboratory technique report

Fahim Vohra¹, Amani Al Fawaz¹

¹Department of Prosthetic Science, SDS, College of Dentistry, King Saud University, Kingdom of Saudi Arabia

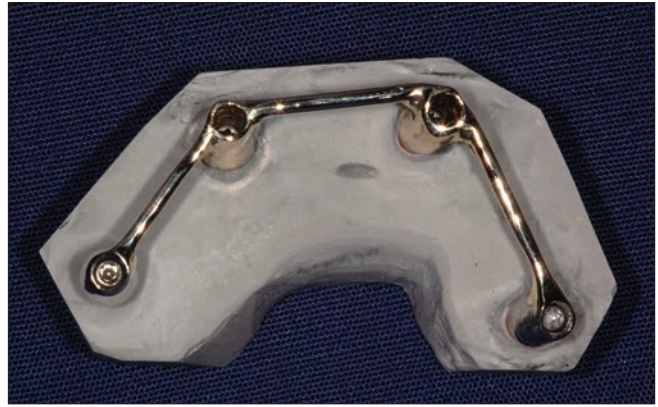
Figure 10: Repaired, finished, and polished gold bar retainer assembly, ready for intra-oral fit

8. After bench cooling, the assembly is divested [Figure 9] using sandblasting and the gold solder was adjusted using coarse rubber disc and polishing was completed using a burlew/gold lustre blue disc (Shofu Dental Corp, St Marcos, CA, USA) [Figure 10].
9. The repaired bar and coping assembly was removed from the implant analogs and placed intra-orally after adequate disinfection and were found to connect passively on all four implants.
10. The maxillary implant overdenture prosthesis was stable on fit, and the patient was delighted with the excellent result. The repaired Dolder bar/gold coping assembly was fitted the same day, and the patient was able to wear a stable overdenture within just four hours.
