A Rare Case of Dacron Graft Rupture due to Friction against a Rib

Thorac Cardiovasc Surg Rep 2014;3:71–72.

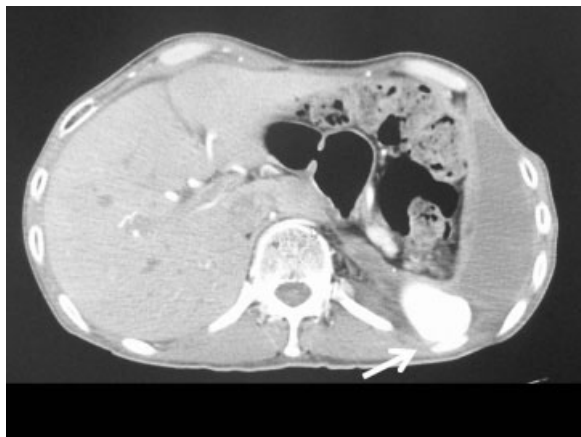
Fig. 1 A postoperative computed tomographic scan after thoracic endovascular aortic repair showing that the graft was closely positioned in contact with the rib (arrow).

the massive hematoma showed that there was no bleeding proximally or distally to the previous anastomosis. However, there was an oozing type of bleeding from a small hole in the previous Dacron. The small hole was located completely compatible with the site in contact with the 10th rib, which lacked periosteum (▶ Fig. 3). The margin of the hole was dull. The Dacron graft rupture was considered due to its friction against the rib. The hole was directly closed with 4–0 Prolene (Ethicon, Somerville, New Jersey, United States). In addition, the graft was wrapped with another Gelweave Dacron prosthesis, and positioned apart from the chest wall to prevent another mechanical graft injury. Intraoperative cultures taken at the time of surgical exploration of the disrupted graft showed all negative. The postoperative course was uneventful, and the patient was discharged after a hospital stay of 10 days. He is doing well 2 years after surgery.

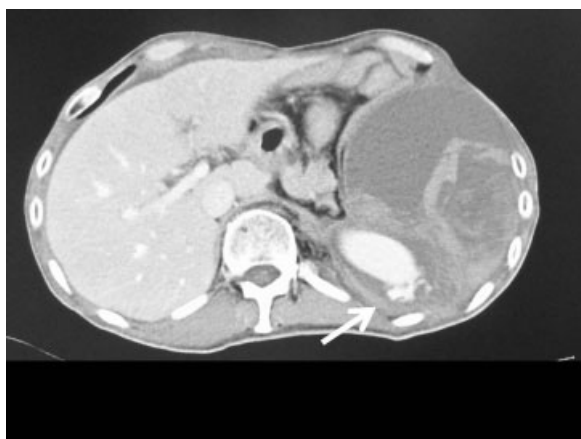
Fig. 2 A computed tomographic scan demonstrating active contrast extravasation (arrow) and a massive hematoma around the graft.

A 54-year-old man had undergone combined esophagectomy and graft replacement of the descending aorta for aorto-esophageal fistula, due to a chronic erosion of a large descending aortic aneurysm and the esophagus 1 year ago. Although he had been doing well, the extent III thoracoabdominal aorta progressively dilated, complicated with infection. He had urgent thoracoabdominal aortic repair with a Gelweave woven Dacron multibranched graft (Vascutek, Renfrewshire, Scotland) treated with gentian violet. Postoperative computed tomographic (CT) scans showed no recurrence of the infection, with the graft located close to the 10th rib (▶ Fig. 1). Four months later, he presented with sudden back pain and was referred to our hospital. On admission, he was in preshock status, and laboratory data revealed hemoglobin levels of 5.2 mg/dL. CT scans demonstrated active contrast extravasation and a massive hematoma around the graft, suggesting graft rupture (▶ Fig. 2). Emergency thoracic endovascular aortic repair (TEVAR) as a bridge use was successfully performed for the hemostasis, and subsequently stable hemodynamics were obtained. Open repair was subsequently performed. Operative findings after the removal of

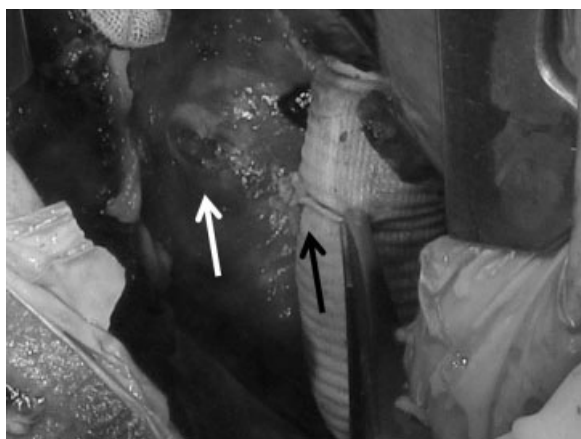
Fig. 3 Operative findings. The black arrow shows the repaired rupture site of the graft. The white arrow shows the rib without periosteum.

With regard to the treatment for such a rare complication, endovascular repairs are quicker and easier. Open repairs need some time for body positioning, thoracotomy, and cardiopulmonary bypass, although they are more durable than endovascular repairs. Consequently, we employed two-stage repairs with bridge use of a stent graft. In the second stage, simple wrapping of the Dacron graft with another Dacron prosthesis with direct closure of the graft injury was chosen because it was easier and did not require a cardiopulmonary bypass.
