## Fractured needle during endoscopic ultrasound-guided fine-needle aspiration of a pancreatic head mass

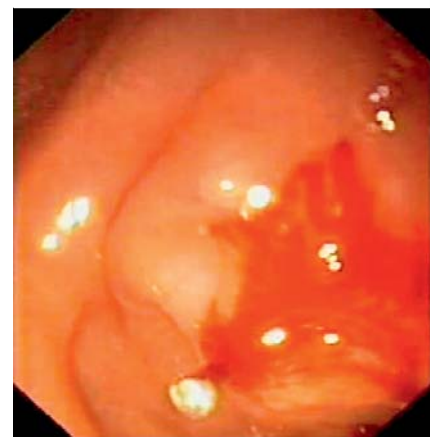
**Fig. 2** Endoscopic image of the extremity of the needle fragment protruding from the duodenal bulb.

The procedure was performed by an experienced endosonographer from the duodenal bulb using a 22-gauge needle. The needle was inserted into the periphery of the mass to avoid passing through the plastic stent, and the fanning technique was used. At the end of the first pass, an unusual hyperreflecting line was observed, corresponding to the needle tract (▶ Fig. 1), which suggested that the needle may have broken during the sampling procedure. This was confirmed when the needle was advanced outside the external sheath to collect the specimen. The extremity of the broken needle was further identified protruding from the mucosa of the upper duodenal bulb (▶ Fig. 2).

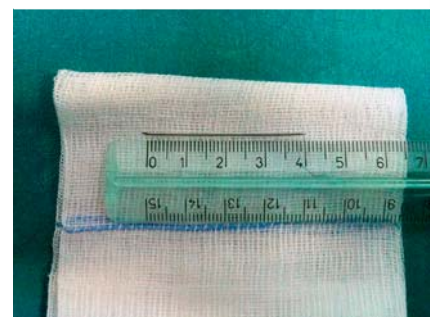
**Fig. 3** Image of the removed fractured needle fragment, which measured 4 cm in length.

After various attempts at retrieval, the needle was grasped from the terminal end using a snare and was removed completely, without any consequences to the patient. The needle segment measured 4 cm (▶ Fig. 3, ▶ Video 1). There was no obvious cause of this incident. However, it is possible that the plastic stent could have been a relevant factor in the breaking of the needle.
