Polyethylene Tibial Post Fracture in a Posterior Stabilized (Genesis II) Total Knee Arthroplasty

J Knee Surg Rep 2015;1:60–63.

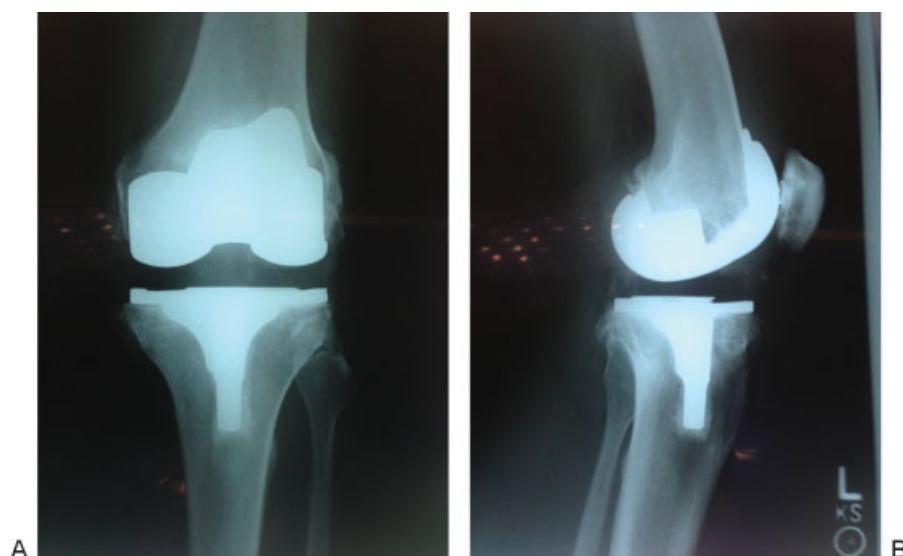
Fig. 1 (A) Anteroposterior radiograph of knee after injury. (B) Lateral radiograph of knee after injury.

femoral component, size 6 tibial component, 38 mm patella button, and 13 mm high flexion posterior stabilized polyethylene insert were used. Intraoperatively, the patient was found to have good stability to varus/valgus as well as anterior/posterior testing. The patella tracked well and there were no signs of midflexion instability. Range of motion intraoperatively was full extension to 120 degrees of flexion. The surgery went without complication, and the patient did well in the postoperative period. Approximately 4 years later, the patient felt pain in the left knee while completing personal resistance squats at the gym. He continued to experience multiple episodes of his knee locking up with continuing pain. Physical examination showed increased posterior sag and laxity with evidence of midflexion instability. X-rays did not show any signs of loosening of any components or signs of instability (► Fig. 1A, B). Based on the clinical findings and the patient's symptoms, he was taken back to the operating room for open exploration and possible revision.

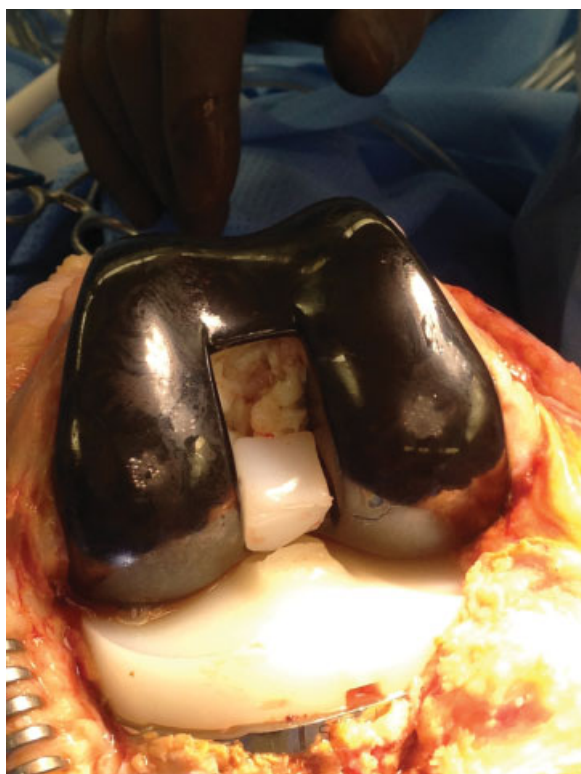
The patient's previous midline incision and medial parapatellar arthrotomy were utilized. Immediately upon exposing the joint, the fractured post was found sitting anterior to the polyethylene insert and tibial component (► Fig. 2). The femoral, tibial, and patellar components were inspected and found to be stable and well fixed. The insert was then

Fig. 2 Photograph of fractured polyethylene tibial post discovered during surgical exposure.

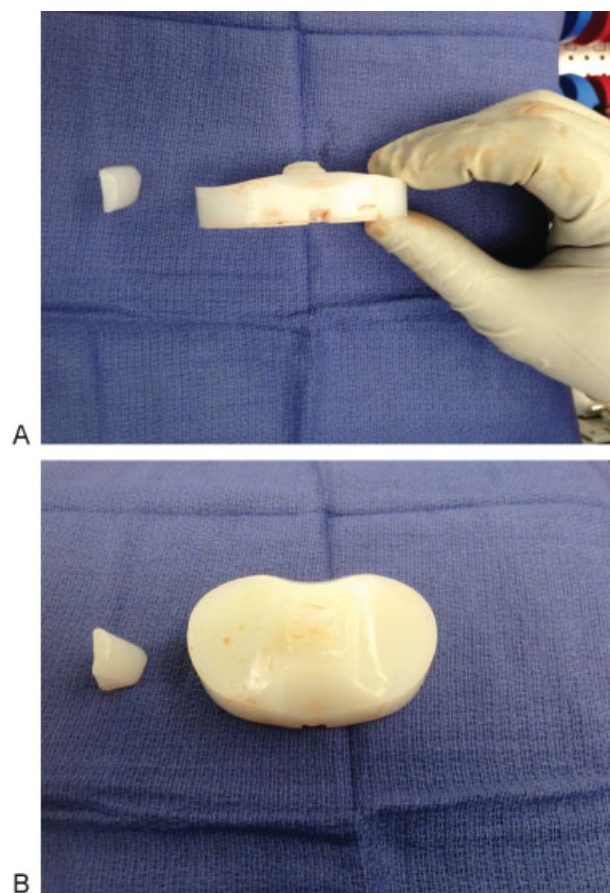
removed from the knee and examined. There were no signs of significant wear along the medial or lateral compartments. The post also showed no signs of increased wear (►Fig. 3A, B). A size 18 posterior stabilized polyethylene insert was then inserted into the knee (►Fig. 4). The knee was examined for varus/valgus, anterior/posterior, and midflexion stability and

Fig. 3 (A) Anterior aspect of the polyethylene insert showing the post fracture. (B) Superior view of the polyethylene insert with fractured post.

Posterior stabilized knee prostheses have the design feature of a cam and post to replicate native kinematics. The cam engages the post during flexion and results in femoral rollback. However, this mechanism increases the potential for higher wear and failure especially in the setting of anterior post impingement. This can be the result of placing the

femoral component in flexion, cutting the tibia with increased posterior slope, knee hyperextension, posterior placement of the femoral component, or anterior tibial tray placement.³ The post is also at risk with deep flexion as this can place significant shear stress across the post.⁵ Multiple reports of post fracture have been published, and anterior impingement and deep flexion mechanisms have been consistently described.⁴⁻⁹

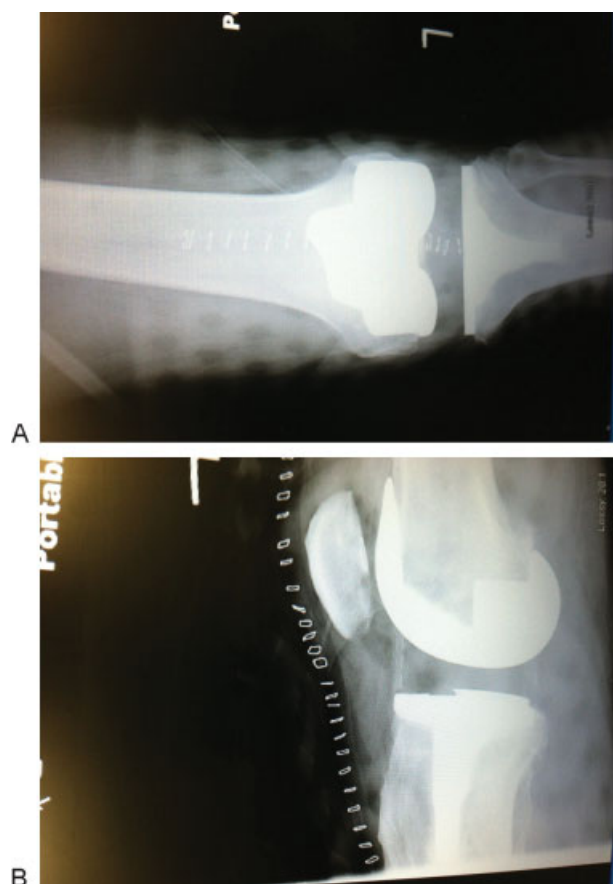
Fig. 5 (A) Anteroposterior radiograph after revision surgery. (B) Lateral radiograph after revision surgery.

was found to be stable. Patellar tracking was midline. At follow-up, patient was doing well with significantly improved pain and function of his left knee (►Fig. 5A, B).
