Intraoral Repair of All Ceramic Fixed Partial Denture Utilizing Preimpregnated Fiber Reinforced Composite

ABSTRACT

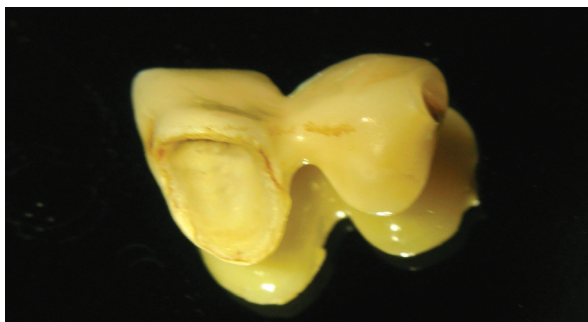
32 years old male patient was referred to our clinic due to distal connector fracture of the three unit heat-pressed lithium disilicate-reinforced glass ceramic (IPS-Empress 2, Ivoclar, Vivadent, Schaan, Liechtenstein) FPD. Two all-ceramic FPDs were constructed 5 years ago because of missing lateral incisors but canines were in lateral incisors' position. The abutment teeth and the all ceramic FPD units both were in good condition except the fractured connector. Having observed that the pontic was disconnected from the distal crown and additionally luting cement was detached from the mesial abutment tooth 22 previously; the crown and the still attached pontic was removed from the mesial abutment tooth (Figure 1). The

Figure 1. The mesial retainer crown and the pontic separated from the distal crown because of connector fracture.

failures due to the crack propagation from the veneer surface is expected to occur even for shorter 3-unit bridges for the IPS-Empress 2.^{2,13} In the presented case report, the reason for the initial failure was probably due to the fact that, the connector was not satisfying the recommended minimum thickness criteria for the standards of heat-pressed lithium disilicate-reinforced glass ceramics as the gingivo-occlusal space was limited.

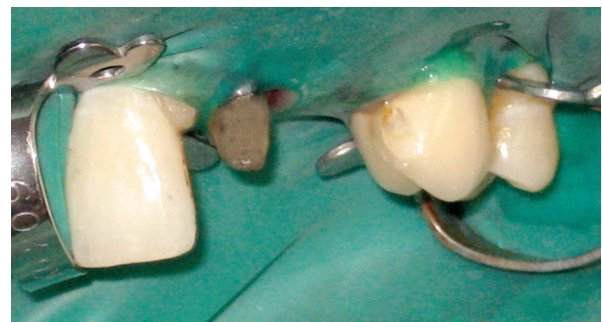
Figure 2. The isolated restoration area utilizing rubber-dam.

area was isolated by use of a rubber-dam and grooves prepared both on the occlusal part of distal crown intraorally and on the palatal side of pontic extraorally (Figures 2 and 3). The grooves were treated with air-particle abrasion using 50 μm Al_2O_3 (Korox, Bego, Germany) with a chair side air-abrasion device (CoJet, 3M-ESPE, Germany) from a distance of 10 mm at a pressure of 250 kPa bar for 10 s. Air-particle abraded surfaces were treated by 9% hydrofluoric acid (Pulpdent Corporation, USA) for 5 min and finally a silane coupling agent (Pulpdent Corporation, USA) was applied (Figure 4) and air-dried.

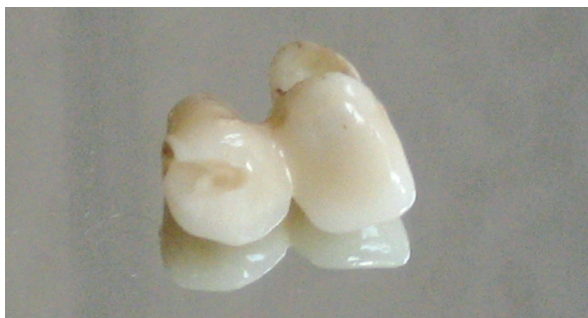
Figure 3. Groove formed on the palatal side of the pontic.

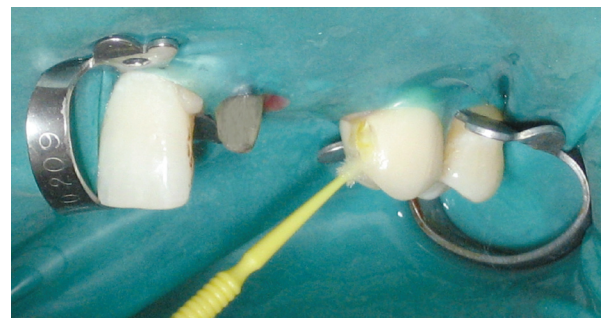
Figure 4. The grooves were acid etched with 9 % hydrofluoric acid and silane coupling agent was applied.

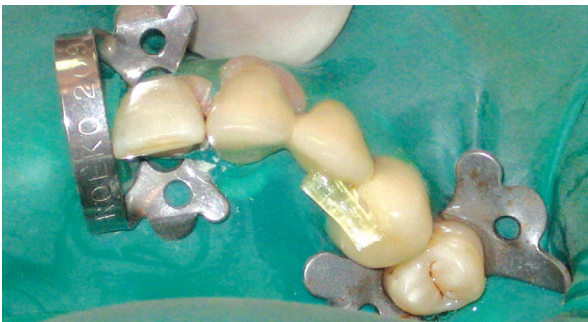
Figure 5. FRC was cut 0,5 mm short of finish line of grooves.

Before application, preimpregnated unidirectional E-glass FRC (EverStick C&B, StickTech, Finland) was cut 0.5 mm short of the finish line of the prepared grooves (Figure 5) and further-impregnated with light-curing adhesive resin (Stick Resin, Stick Tech, Finland) for 10 min in a dark container. The detached crown was cemented onto the mesial abutment tooth utilizing dual-cure composite resin luting cement (Panavia F2.0, Kuraray, Japan) following the manufacturer's recommendations (Figure 6). Light curing adhesive (One-Step Plus, Bisco, Schaumburg, USA) was applied on the surface of neighbor grooves and light irradiated for 20 s. Flowable composite (Eco-Flow, Ivoclar-Vivadent, Schaan, Liechtenstein)

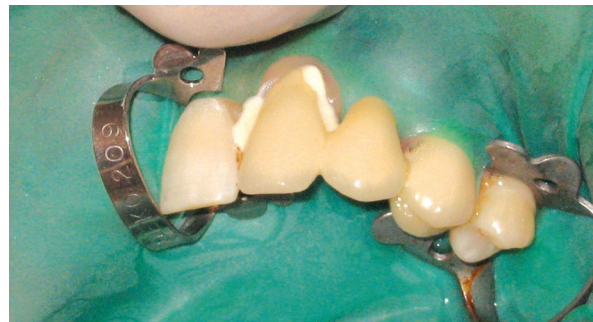
Figure 6. The mesial retainer crown cemented on the mesial abutment tooth.

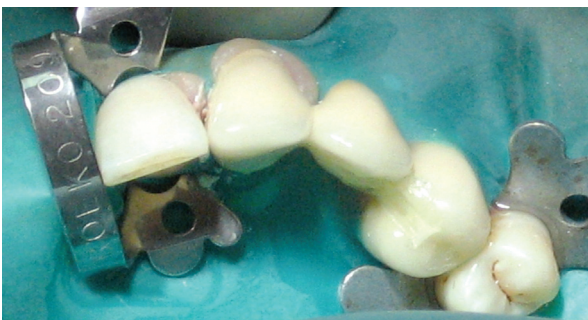
Figure 7. FRC adapted in the grooves utilizing transparent silicone block.

was applied prior to the application of the pre-impregnated FRC and the FRC was adapted in the grooves using a transparent silicone block. Supporting the pontic from the facial side the FRC and flowable composite light irradiated for 40 sec beyond the silicone block (Figure 7). The restored area was covered with flowable composite filling the entire groove and covering the connector area, and light cured (Figure 8). Excess composite was removed with abrasive discs and the restored area was checked to avoid any occlusal interference (Figure 9). Also the pontic checked on lateral excursions to diminish inadequate forces which may lead to re-fracture of restored area. The patient was recalled in 3 weeks (Figure 10) and no complication was observed during 6 months clinic service.

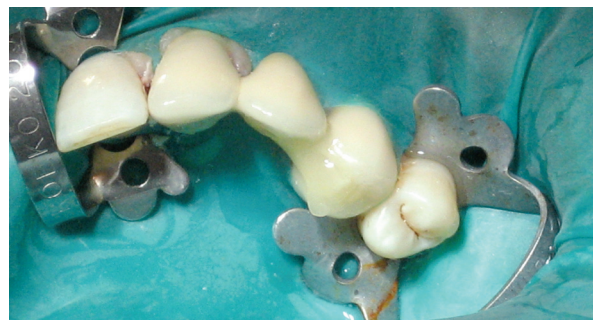
Figure 8. The restored area was covered with flowable composite.

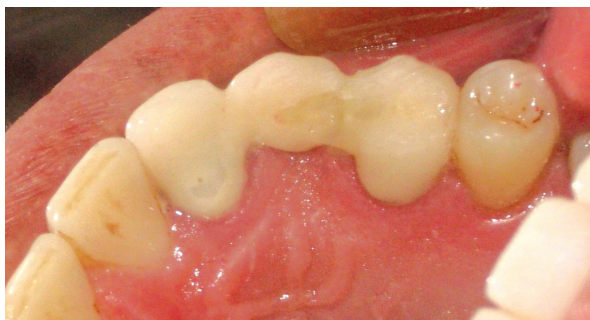
Figure 9. Occlusal view of the restored area after finishing and polishing procedures.

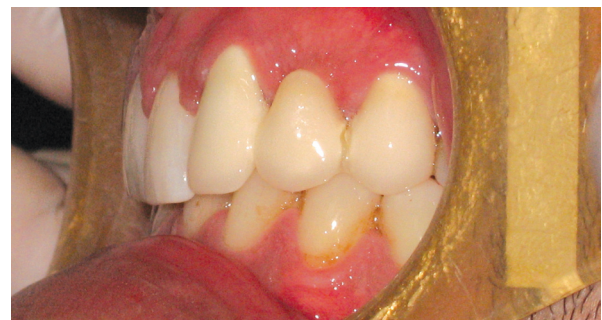
Figure 10. Facial view of the restored area after 3 weeks.
