Abdominal Aorta Anastomotic False Aneurysm Leading to Double Focal Vertebral Body Erosion

Aorta (Stamford) 2022;10:41–42.

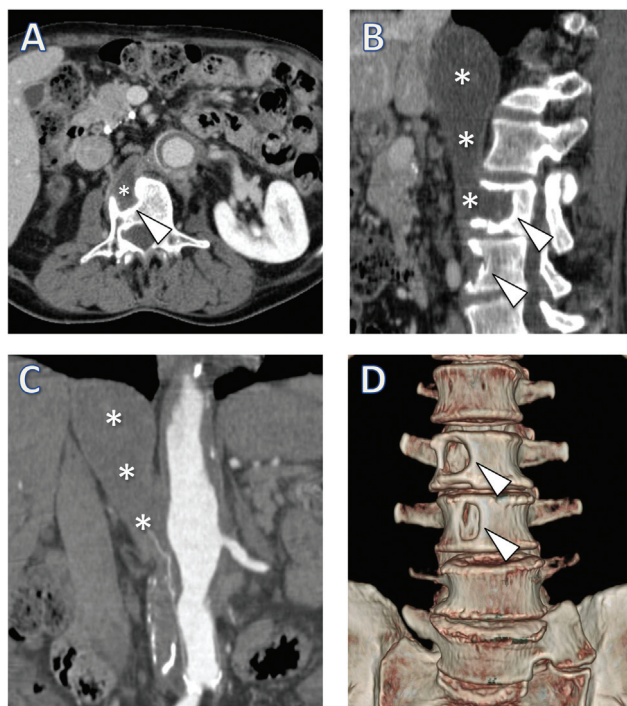
A 77-year-old male patient underwent open repair with an aortobifemoral graft for abdominal aortic aneurysm (AAA). Five years later on imaging follow-up, abdominal contrast medium-enhanced multidetector computed tomography (MDCT; ▶ **Fig. 1**) with axial (▶ **Fig. 1A**), sagittal, and coronal multiplanar reconstruction (▶ **Fig. 1B, C**) and coronal volume rendering technique reconstruction (▶ **Fig. 1D**) demonstrated a 15.6 × 4.1 cm thrombosed pseudoaneurysm (shown with * in ▶ **Fig. 1**) at the level of the proximal abdominal aorta anastomosis, with a vertical course extending from the diaphragmatic dome to the third lumbar vertebra, associated with focal erosion of the second and third lumbar vertebral bodies (arrowheads), with well-delimited bone sclerotic margins. No MDCT signs of infection were noted. Blood cultures were negative.

Fig. 1 Imaging studies of the reported case. (A) Axial view. (B) Sagittal view. (C) Coronal view. (D) Three-dimensional reconstruction. Asterisks (*) mark Thrombosed pseudoaneurysm. Arrowheads mark vertebral body erosions.

The postoperative course was uneventful, with continuous negative blood culture results. MDCT follow-up exams demonstrated exclusion and reduction in size of the anastomotic pseudoaneurysm, with stability of vertebral lytic lesions.
