Nonadherence of Polyurethane Implants: A Retrospective Cohort Study

Indian J Plast Surg 2024;57:24–30.

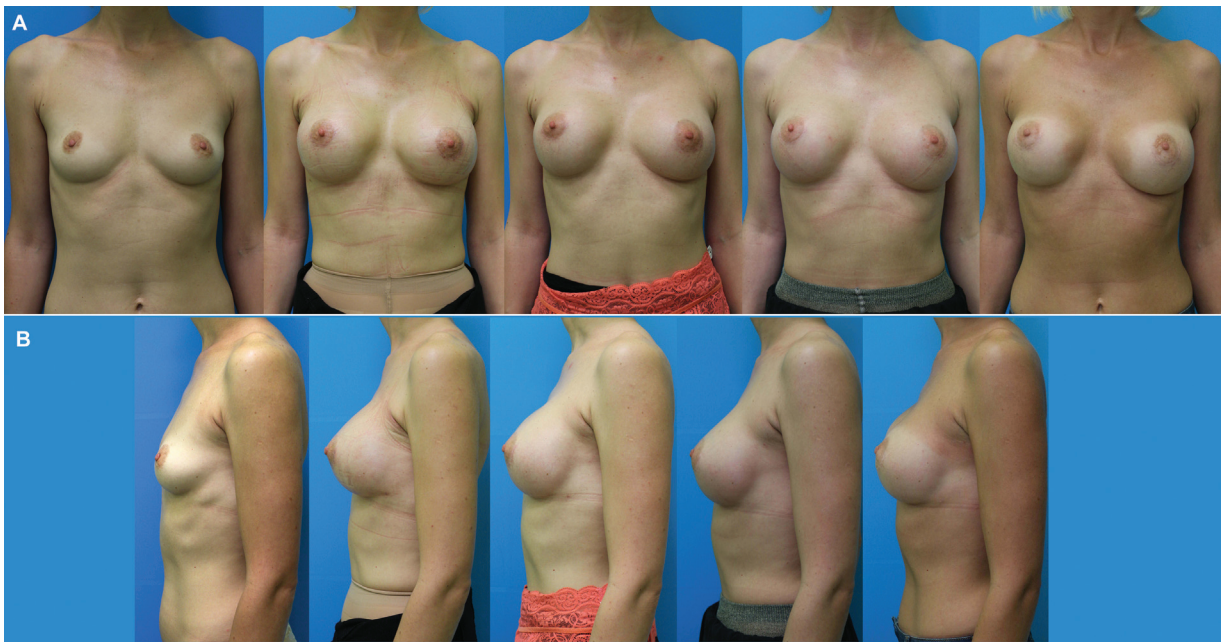
Fig. 1 (A, B) Primary nonadherence of polyurethane (PU) implants on the left side. Dynamics at 1, 3, 6, and 12 months after breast augmentation with PU implants.

Analyzing our cases of primary nonadherence, we noticed that in one case small hematoma on the left which we decided to treat conservatively was diagnosed shortly after the surgery (►Fig. 1). The presence of blood in the pocket disconnects the implant from the surrounding tissues thus preventing biointegration. We consider it the definite factor of primary nonadherence.

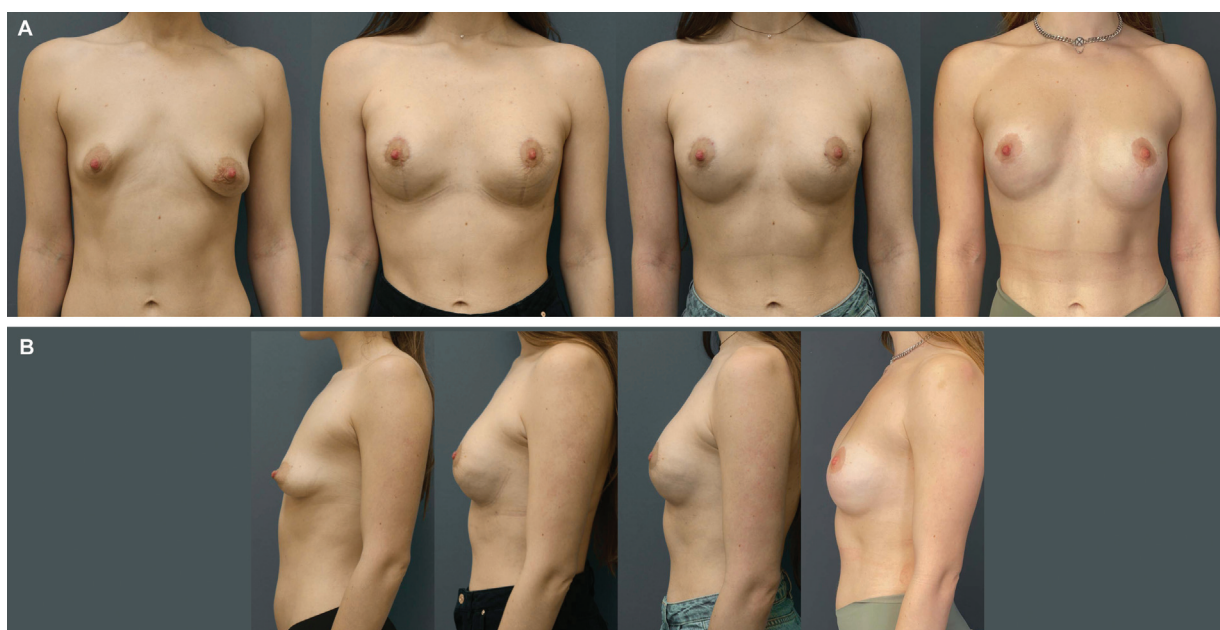
Fig. 2 (A, B) Secondary nonadherence of polyurethane (PU) implant on the left side. Dynamics at 3, 6 months, 2.5 years after breast augmentation with PU implants and mastopexy.

one implant found considerably lower than the other, NAC facing higher than it was and N-IMF distance lengthened (►Figs. 2, 3).

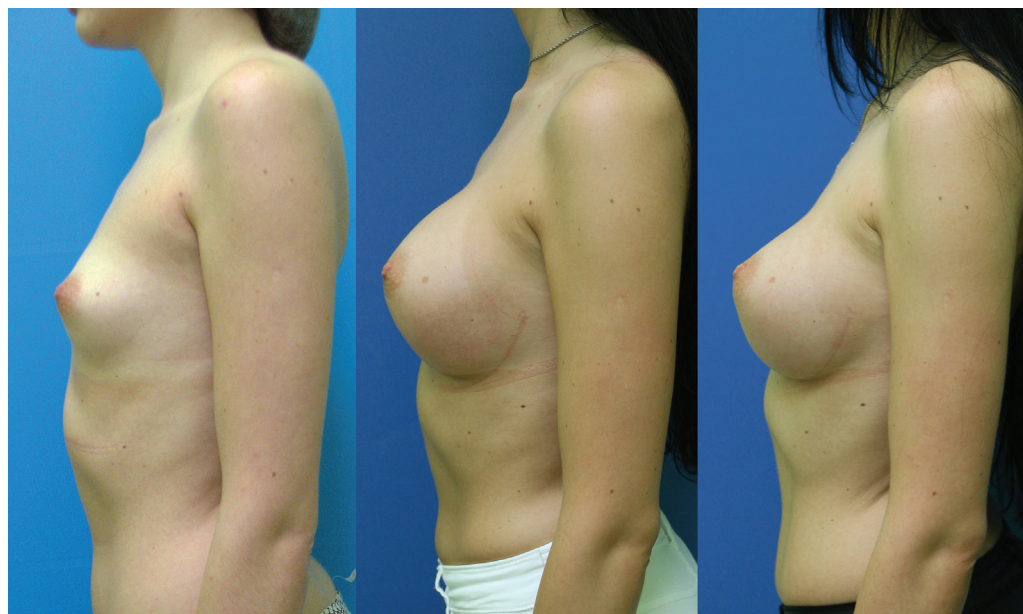
Fig. 3 Secondary nonadherence of polyurethane (PU) implant on the left side. Dynamics at 3 years, 7 months and 4 years after breast augmentation with PU implants.

In all of our five patients with secondary nonadherence, the problems began at least 1 year after the surgery. One patient directly named the reason, trauma, after which the implant lost its adherence to the capsule. One patient (→Fig. 3) came for the follow-up visit with seroma (BIA-ALCL was ruled out according to the established pro-

ocols) that resulted in nonadherence in a few months. In three patients, however, we did not find any reasonable factors.
