## A safe technique for removing a malpositioned covered biliary self-expandable metal stent

Endoscopy 2008; 40: E165

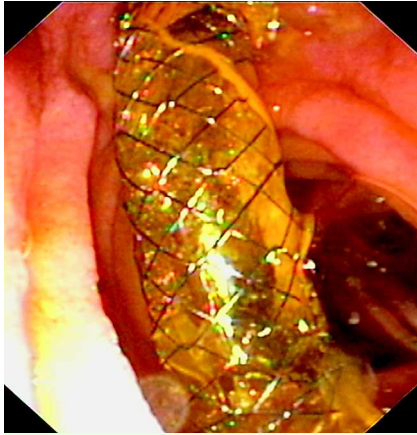
**Fig. 1** Malpositioned covered self-expandable metal stent (SEMS) protruding into the duodenum.

duct. Four months later, the patient presented with cholangitis. Endoscopic retrograde cholangiopancreatography (ERCP) was performed, and suggested tumor overgrowth within the SEMS. A second, 100-mm covered SEMS (Shim-Hanaro; MI Tech, Seoul, Korea) was inserted through the previously placed SEMS. Unfortunately, the covered SEMS was poorly positioned, with a large part of the stent protruding into the duodenum (► Fig. 1). A polypectomy snare (1.5 × 3 cm; Wilson-Cook Medical, Winston Salem, North Carolina, USA) was advanced through a regular 10-Fr pushing catheter (Cook Ireland, Limerick, Ireland), inserted through the accessory channel, and the duodenal

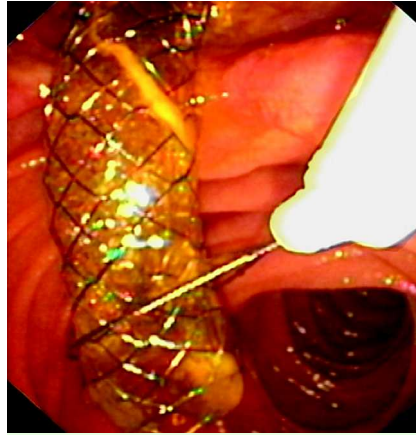
**Fig. 2** Polypectomy snare grasping the distal end of the malpositioned SEMS.

end of the covered SEMS was grasped (► Fig. 2). By gentle pulling on the polypectomy snare, the SEMS slowly collapsed and could be withdrawn inside the pushing catheter (► Fig. 3 and ► Video 1), which was subsequently withdrawn through the duodenoscope. Finally, an 80-mm uncovered SEMS (Wallstent) was placed within the originally inserted SEMS, this time in a good position (► Fig. 4).

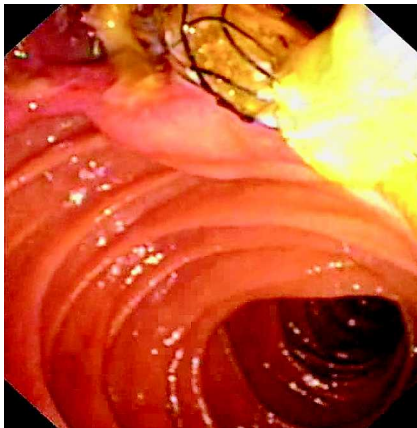
**Fig. 3** SEMS being pulled inside the pushing catheter.

Several techniques have been described for removing a biliary SEMS. Our technique for removing a malpositioned SEMS has not been described before, is relatively easy, and carries no risk of scope damage or intestinal perforation, since the wire filaments at the distal end of the SEMS are covered within the pushing catheter.

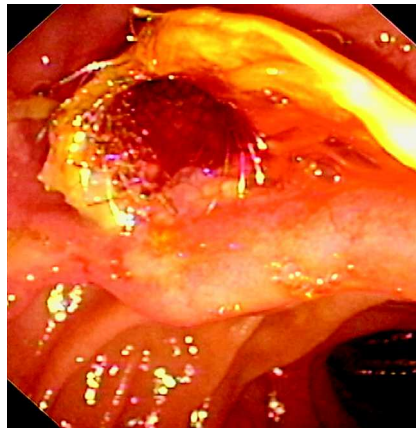
**Fig. 4** Appearance after removal of the malpositioned stent and insertion of a second uncovered SEMS.
