K-Wire Breakage During Metalware Removal Due to a Defective K-Wire Shaft

Seong Jae Hong, Hyun Jic Lee, Jin Young Kim,
Su Rak Eo, Sang Hun Cho

Department of Hand/Upper Extremity Service, Dongguk University Ilsan Hospital, Dongguk University Graduate School of Medicine, Goyang, Korea

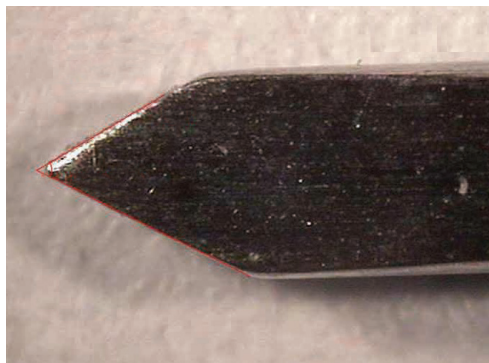
Fig. 4. The tip of the broken K-wire was relatively sharp and had the same angle as the normal K-wire (40× magnified).

was allowed. At 6 weeks postoperatively, radiologic union was achieved using plain radiography, and we attempted to extract the two K-wires. One of the K-wires was completely removed but the other broke at its mid-shaft (Fig. 2), leaving the remnant proximal portion buried in the medullary cavity (Fig. 3). Subsequently, the patient was able to flex and extend the MP joint fully and no symptoms such as pain, bleeding, or swelling were encountered. We noticed that the tip of the broken K-wire resembled the tip of the intact extracted wire. To determine the cause of the breakage, both K-wires were sent to the head office of the manufacturer (Solco Biomedical Co., Ltd., Pyeongtaek, Korea). We observed that the broken tip resembled the end of a normal K-wire tip in magnified view ($40\times$ magnification) (Fig. 4), signifying that the breakage was caused by a manufacturing defect.

This report is the first to document K-wire breakage due to a manufacturing defect. It was difficult to identify the shaft defect responsible intraoperatively because the broken wire had an appearance similar to the normal wire. In fact, the defect was noticed only after pin removal and close examination of the broken tip.
