# Pictorial essay: Artifacts in cardiac CT: A practical system of understanding and correction

Hemant B. Telkar

Department of Radiology, Jupiter Heart Scan, Mumbai, India

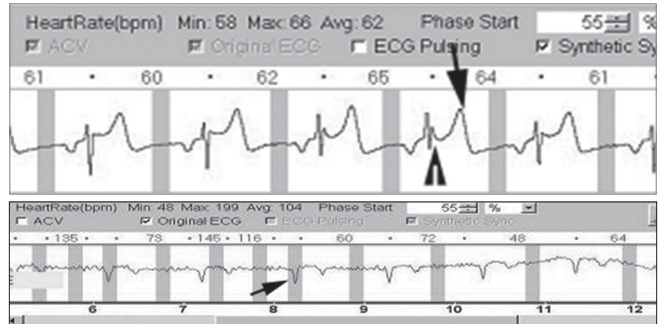
**Figure 7:** Abnormal amplitudes. The ECG trace (A) shows a T wave (arrow) of larger amplitude than the R wave (arrowhead). Another trace (B) shows very low amplitude R waves (arrow).

- a. Abnormal amplitudes [Figure 7]
- b. Baseline tremors [Figure 8]
- c. Wave-form artifact [Figure 9]

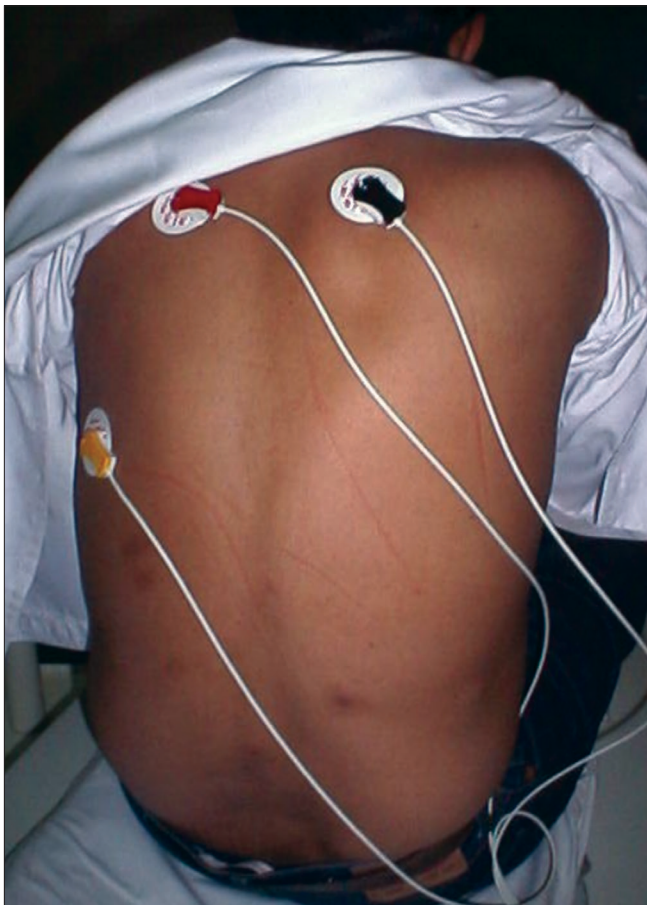
**Figure 10:** Alternate ECG lead placement. The photograph shows ECG leads placed on the back.

The above changes can be prevented by proper placement of electrodes, with good use of jelly for proper contact and to affix the leads after raising the patients' hands above their heads, so as to prevent creasing of the skin under the lead pads. Occasionally, we can change the position of the leads, such as, by putting them on the back [Figure 10]. Breasts can be strapped if they come in the way.

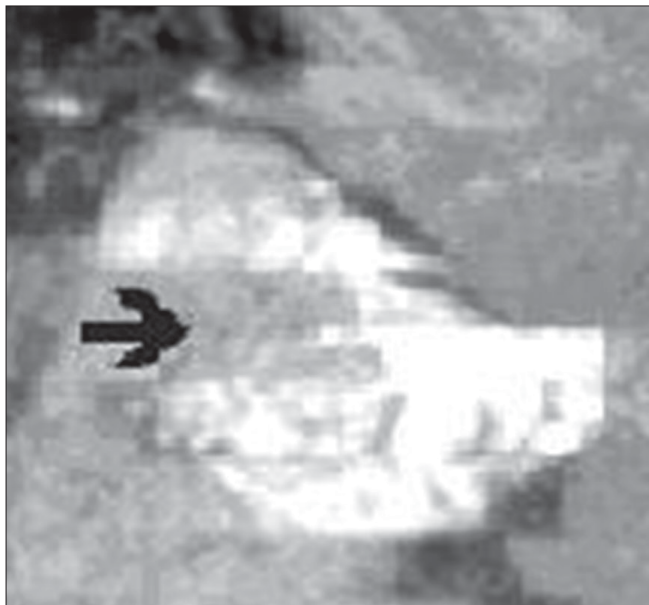
**Figure 15:** MIP image show a "slab" artifact (arrow) due to differential contrast opacification.

These are caused by the improper use of contrast medium. Often, the concentration of contrast medium is locally too high or the contrast medium injection may have started too early. This gives rise to "contrast" slabs [Figure 15].

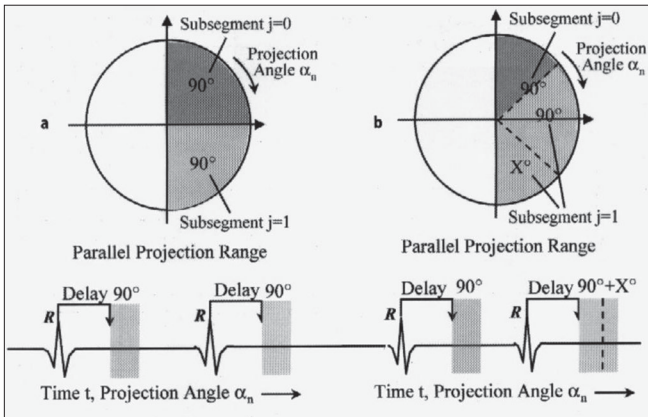
**Figure 17:** Diagram showing the concept of multi-sector reconstruction, using the ACV (Adaptive Cardio Volume TM) mode for Siemens scanners.

In dual-sector reconstruction, the temporal window can be reduced to a maximum of 1/4<sup>th</sup> of the gantry rotation time [Figure 17]. This increases the flexibility and placement of the temporal window in the shortened R-R interval at high heart rates.
