A stent-removing thread sticking adjacent to the duodenoscope elevator identified using the double-scope technique ▶

Endosc Int Open 2024; 12: E269–E270

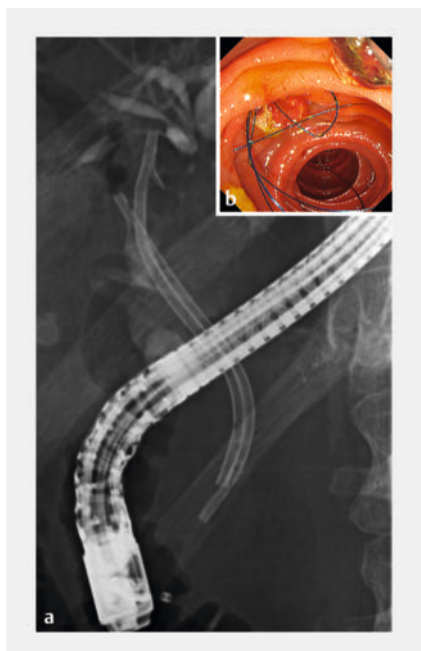
▶ **Fig. 2** Fluoroscopic image with a duodenoscopic view after inside plastic stent deployment. **a** Fluoroscopic image demonstrating double-inside plastic stent indwelling at the hilar stricture in a side-by-side position. **b** In the duodenoscopic view, four removal threads of the plastic stents were washed into the appropriate lumen.

A 65-year-old man with Bismuth type I MHO due to unresectable gallbladder cancer (▶ **Fig. 1**) underwent suprapapillary stenting in a side-by-side fashion using a dedicated PS (Through & Pass, 7F Inside Stent; Gadelius Medical, Tokyo, Japan) (▶ **Fig. 2a**, ▶ **Fig. 2b**, ▶ **Video 1**). The duodenoscope (TJF-Q290V; Olympus, Tokyo, Japan) was extubated after we washed the removing threads out of the scope channel. However, extubation suddenly became disrupted in the stomach (▶ **Video 1**). To identify the cause, a second ultra-slim esophagogastroduodenoscope was inserted along the duodenoscope. We determined that the
