Mitral Valve and Short-Term Ventricular Assist Devices; Potential Mechanical Complications

Thorac Cardiovasc Surg Rep 2013;2:9–12.

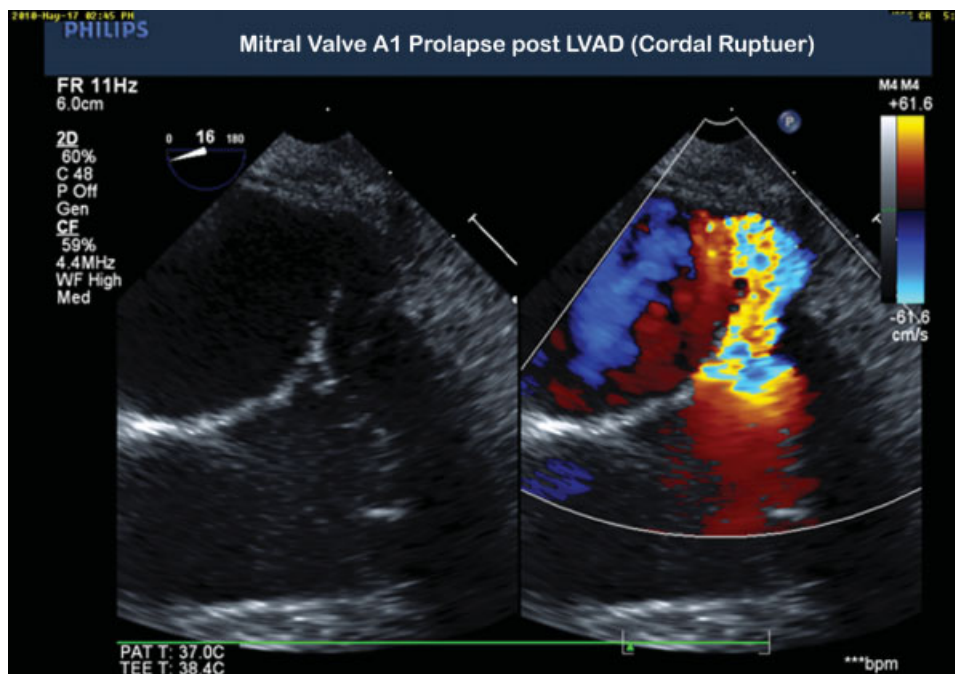
Fig. 1 Transesophageal echocardiogram showing mitral valve A1 prolapse with a posteriorly directed mitral regurge jet.

at the level of A1, and this had damaged the anterior leaflet and disrupted some of the chordal attachments. The valve was repaired by obliteration of the anterolateral commissure and the cannula got redirected away from the mitral apparatus. Postrepair echocardiography showed mild central MR. He was maintained on LVAD and subsequently successfully weaned 15 days after the original surgery, with moderately depressed LV systolic function.

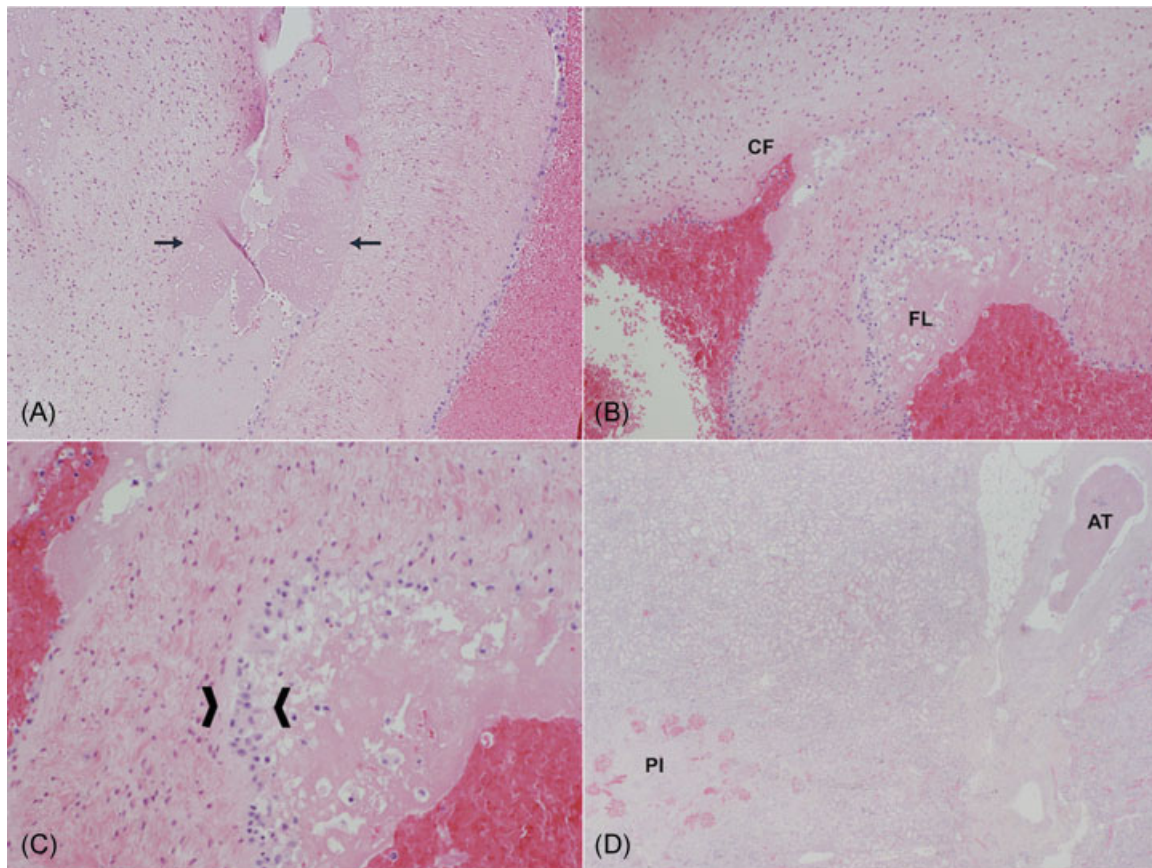
Fig. 2 (A) Photomicrograph demonstrating point of leaflet contact with fibrin thrombus adhesion ($\rightarrow \leftarrow$). (B) Demonstrating fibrin thrombus formation at both sites of contact fusion (CF) and on the free valve leaflet (FL) surface. (C) Note the brisk endothelial proliferative reaction below the fibrin thrombus ($> <$). (D) Section of kidney demonstrating the thromboembolic sequelae with arterial thromboembolus (AT) (upper right) and zone of the renal parenchymal infarction (PI) (lower left).

was extubated two days postexplant. Unfortunately, on day 4 after explant, the patient developed acute pulmonary edema. A TEE showed severe right ventricular dysfunction with severe bioprosthetic mitral valve stenosis, with a peak gradient 13 mm Hg, due to fusion of the mitral leaflets. The patient progressed to develop low cardiac output and passed away. On autopsy, it was evident that the bioprosthetic mitral valve leaflets were fused. This fusion was composed of a thin layer of fibrin thrombus with subjacent reactive endothelial proliferation (► Fig. 2A–C). The spleen and kidneys also showed evidence of arterial thromboemboli (► Fig. 2D).

Here, the authors report two rare complications of the mitral valve secondary to short-term LVAD. In the first case, the position of the inflow cannula in the left atrium was verified by TEE during the VAD insertion, and there was no sign of flow impairment during the postoperative period. The tip of the cannula came in contact with the anterior mitral valve leaflet when the atrium was emptied, causing a cordial rupture that led to mitral insufficiency. This was secondary to the small size of the left atrium and the choice of a large inflow cannula, which led to significant friction between the cannula and the anterior mitral leaflet. In the second case, the choice of LA cannulation and the complete off-loading of the LV led to continuous contact, which caused fusion of the bioprosthetic valve leaflets and the development of fibrinous inflammation.
