Radiographic Evaluation of Hip Implants

Semin Musculoskelet Radiol 2015;19:12–20.

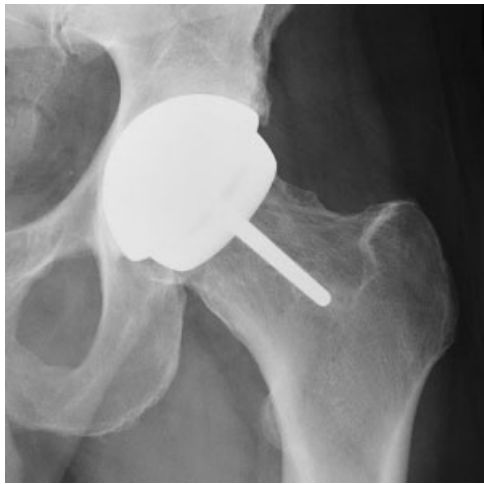
Fig. 1 Frontal radiograph of the left hip in a 60-year-old man showing normal appearance of a resurfacing arthroplasty. The femoral head is cemented, but the cement is not visible on radiographs. The metaphyseal stem is noncemented. There is no periprosthetic lucency, and the femoral stem is essentially parallel to the long axis of the femoral neck.

The femoral component of a RA should be ~ 5 to 10 degrees valgus relative to the femoral neck. Varus or excessive valgus angulation can lead to notching and fracture or loosening as a result. Depending on the manufacturer, the acetabular component should be in 30 to 50 degrees of abduction and 15 to 25 degrees of anteversion.^{25,26}

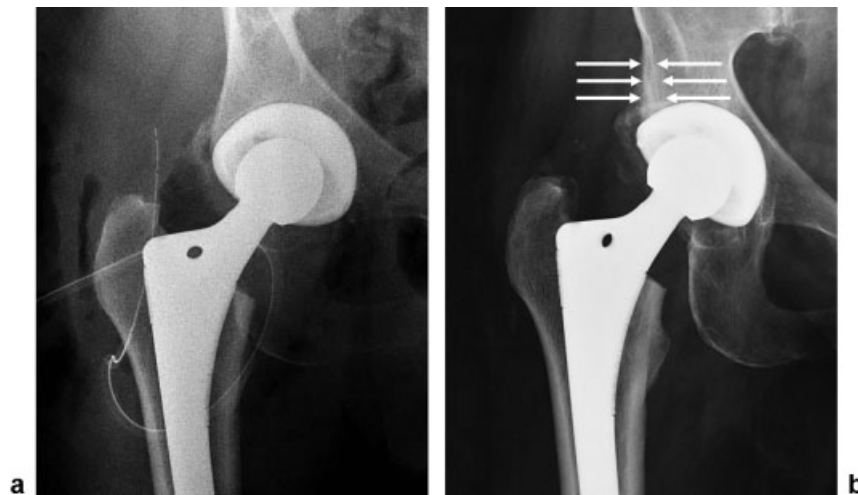
Fig. 5 A 73-year-old woman with noncemented right total hip arthroplasty. (a) Portable frontal radiograph in the immediate postoperative period shows gross anatomical position of the implant, a surgical drain, and soft tissue gas. (b) Frontal radiograph of the right total hip arthroplasty ~ 6 weeks later shows superolateral buttressing (arrows).

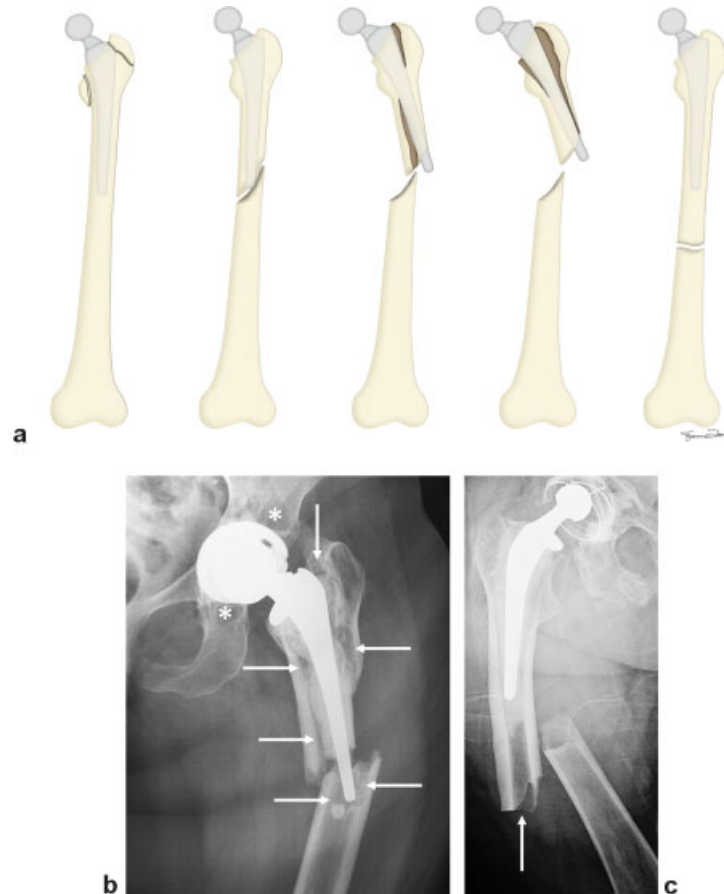
Fig. 14 Vancouver classification for periprosthetic femoral fractures. (a) Schematics of a left femur show that the fractures are divided anatomically: Type A is a greater or lesser trochanteric fracture, type B is in the diaphysis just distal to the tip of the stem, and type C is far distal to the stem and essentially a nonrelated separate fracture. Type B is further divided: Type B1 has adequate bone stock and shows no radiographic findings of loosening, type B2 is a loose component with adequate bone stock, and type B3 is a loose component with inadequate bone stock. (b) An 80-year-old woman with a left total hip arthroplasty with a cemented femoral component and a noncemented acetabular component. There is a periprosthetic femur fracture at the level of the distal aspect of the femoral stem. Additionally, there are extensive periprosthetic and bone–cement interface lucencies involving essentially all of the femoral component (arrows) and DeLee and Charnley zones I and III of the acetabular component (asterisks). The constellation of findings represents a Vancouver type B3 periprosthetic fracture. (c) An 85-year-old woman with a right total hip arthroplasty with cemented femoral and acetabular components. There is a periprosthetic femur fracture centered several centimeters distal to the tip of the femoral stem, representing a Vancouver type C periprosthetic fracture. Also noted is superolateral location of the femoral head with respect to the acetabular cup, indicating asymmetric liner wear.

Periprosthetic femoral fractures can be described using the Vancouver classification, seen in ►Fig. 14. Types B1 and B2 are the most common periprosthetic fractures in primary (61%) and secondary (44%) THAs, respectively. The fractures can also be categorized as a simple cortical perforation, a nondisplaced linear fracture, or a displaced and unstable fracture, because the category affects the management.^{50–52}
