# Internal Fixation of a Complicated Mandibular Fracture in a Filly Using a String-of-Pearls Locking Plate Assisted by a 3D Printed Model

**Objective** The aim of this study was to describe the successful surgical treatment of a complicated mandibular fracture with a 3.5 mm string-of-pearls (SOP) locking plate in a 5-month-old Appaloosa filly presenting with neurological signs.

**Study Design** This is a case report.

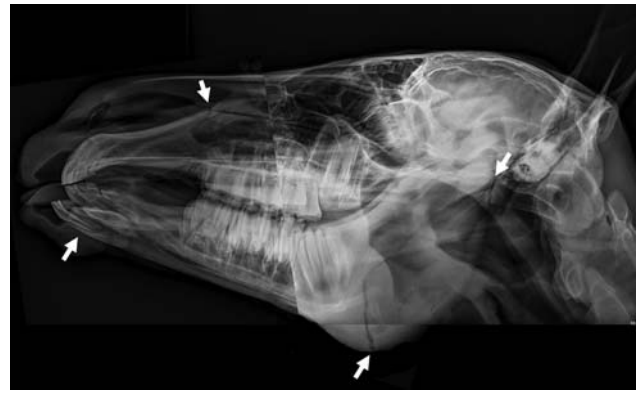
**Fig. 1** Composite lateral radiograph several mandibular and maxillary fractures in a 5-month-old filly. From left to right, the white arrows indicate the mandibular symphyseal fracture, rostral maxillary fracture, cranioventral and caudal-ventral aspects of a displaced mandibular fracture.

Radiographic examination confirmed the presence of a unilateral symphysis fracture and identified a non-displaced fracture of the left vertical ramus, with a fracture line identified that appeared to extend to the temporomandibular joint (**Fig. 1**). Bilateral rostral maxillary fractures were also identified at this time.

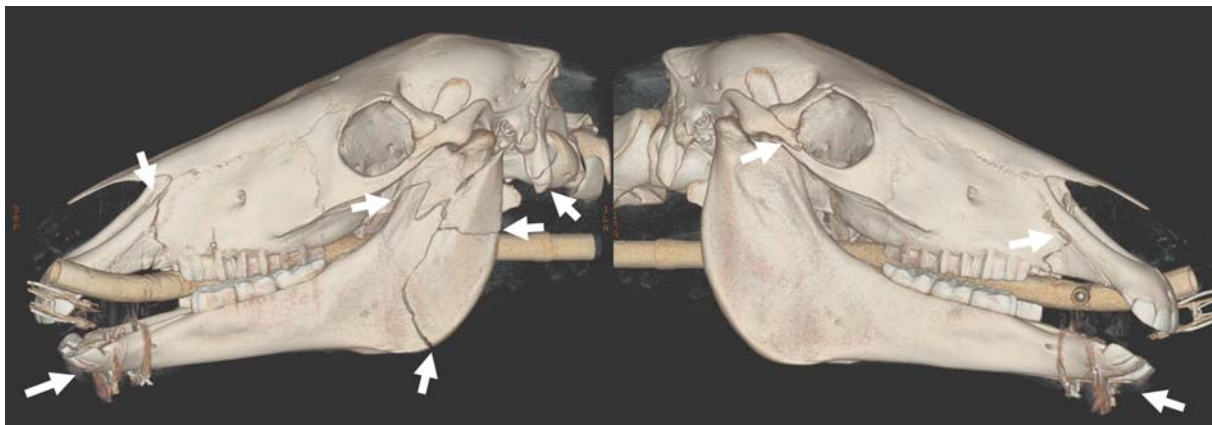
**Fig. 2** Computed tomographic three-dimensional surface render of the skull. From left to right, the white arrows indicate the repaired mandibular symphyseal fracture, left maxilla fracture, comminution and displacement of the left mandibular fracture, left paracondylar process fracture, right zygomatic arch fracture, right maxilla fracture. Not pictured = left basisphenoid fracture.

The CT examination identified a fracture of the right wing of the basisphenoid bone, comminuted fracture of the left vertical ramus, minimally-displaced fractures of the left and right rostral maxilla, the right zygomatic arch and displaced fractures of the left paracondylar process, the lateral cortices of the mandible and the previously repaired symphysis

fracture (►Fig. 2). The temporomandibular joints appeared intact, thus the reason for the lateral malocclusion was determined to be the unstable fractures of the vertical ramus and the left paracondylar process. To further aid in the surgical planning of the repair, a scaled (1:4) three-dimensional (3D) printed model based on the CT reconstruction was made and was available during surgery (►Fig. 3).

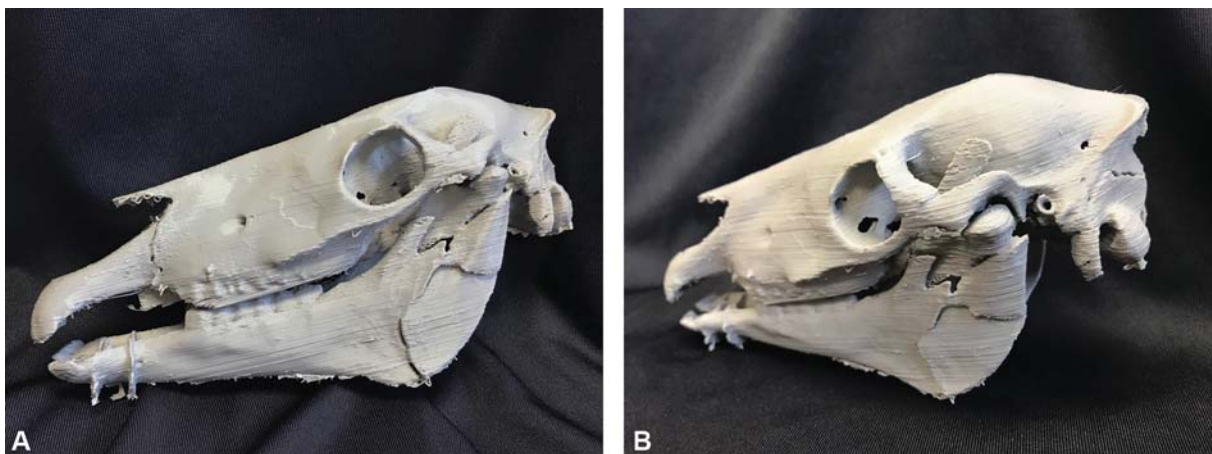
**Fig. 3** (A) Three-dimensional (3D) model of the computed tomographic 3D surface render of the skull. The model was utilized pre- and intra-operative to aid in comprehension of the fracture, aid surgical planning, surgical resident training and for client education. (B) Close up of the 3D model highlighting the vertical ramus fracture.

The CT examination was performed to evaluate the filly's injuries more completely and to determine if there was disruption to the temporomandibular joint, which would have reduced the prognosis considerably.<sup>23</sup> The value of CT in pre-surgical planning in the repair of maxillofacial injuries is well established<sup>24</sup>; the cranium is anatomically complex and the precise position and extent of fracture lines are difficult to infer from radiographs. However, even a reconstructed CT is a 2D representation of a 3D structure, which limits the complete understanding of spatial relationships and may impair decision making.<sup>25</sup> Recently, 3D printing has been utilized in small animal practice to aid in surgical planning for oral and maxillofacial surgery, as well as for enhancing resident training and for client education.<sup>26</sup> In this case, the availability of the 3D model during surgery helped the surgery team to fully appreciate the fracture margins and aided reduction without the need to pause the surgery to assess the CT. A 1:4 scaled model was utilized to cut back on production time; if a full size model had been produced, it would have had the added benefit of allowing for pre-contouring of the plate.

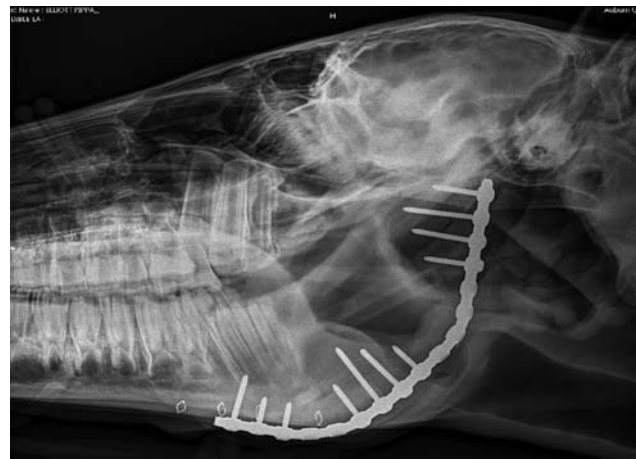
**Fig. 4** Lateral radiograph of the caudal skull obtained 4 weeks postoperatively. The fracture is well reduced and healing appears appropriate.

The surgical staples were removed by the referring veterinarian 2 weeks after surgery, at which time the mild swelling of the mandibular incision had resolved. The filly maintained an excellent appetite. The filly was re-presented at 4 weeks postoperatively and radiographic examination revealed callus formation at the previously identified maxilla fractures. The mandibular fractures appeared to be healing well (► Fig. 4). There was peripheral sclerosis and periosteal reaction of the rostral right mandible associated with the symphyseal wire, indicative of focal osteomyelitis (► Fig. 5).
