Stabilization and Long-Term Outcome of a Tibiotarsal Fracture in a Turkey Vulture (Cathartes aura) Using a Supracutaneous Plating Technique

VCOT Open 2022;5:e111-e115.

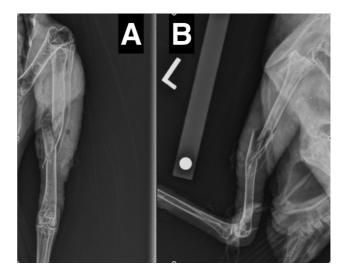
Fig. 1 Ventrodorsal (A) and medio-lateral (B) radiographic projections taken at presentation revealing a closed, highly comminuted mid-diaphyseal fracture of the left tibiotarsus in a wild turkey vulture (*Cathartes aura*).

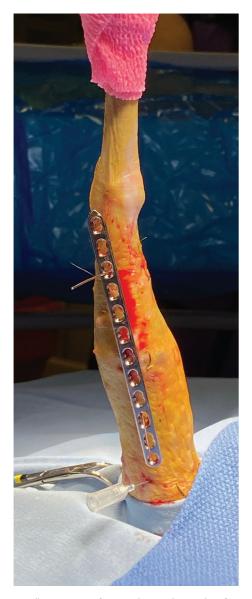
Fig. 2 Image illustrates joint femoro-tibiotarsal joint identification with a 25-gauge needle and placement of an LCP and temporary stabilization with diverging Kirshner wires. LCP, locking compression plate.

The turkey vulture was placed in dorsal recumbency with the left limb suspended. The limb was plucked free of feathers, starting from the mid-femur and extending distally and surgically prepared using a standard aseptic technique. The tibiotarsus-metatarsus and femoro-tibiotarsus joints were identified using a 25-gauge hypodermic needle and their alignment was confirmed under fluoroscopy (OEC One, GE, Boston, Massachusetts, United States) guidance (**Fig. 2**). The anatomical axis was restored with digital manipulation to replicate preoperative imaging of the contralateral limb. A 2-cm incision was made laterally over the proximal and distal metaphysis of the left tibiotarsus. The fit of a 12-hole plate was confirmed using fluoroscopic guidance. A 2.4-mm locking compression plate (LCP) (DePuy Synthes, West Chester, Pennsylvania, United States) was placed exterior to the skin and maintained in position using one diverging 1.1-mm Kirshner wires (IMEX Veterinary Inc., Longview Texas, United States) on either side of the fracture gap. Placement of the diverging Kirshner wires was made with

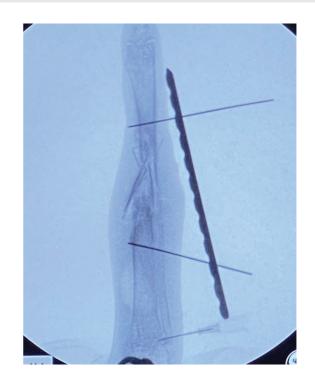
Fig. 3 A fluoroscopic image of the LCP with temporary fixation using diverging Kirschner wires. LCP, locking compression plate.

fluoroscopic guidance by selecting the screw holes over the intact bones that were closest to the fracture gap proximally and distally (**Fig. 3**). The plate was positioned 1 to 3 mm away from the skin and maintained manually by the surgical assistant (M.L.). A 2.4-mm locking guide (DePuy Synthes, West Chester, Pennsylvania, United States) was applied to the selected plate holes and each hole drilled with a 1.8-mm drill bit (DePuy Synthes, West Chester, Pennsylvania, United States). A metric depth gauge (DePuy Synthes, West Chester, Pennsylvania, United States) was used to measure the length of the pilot holes. Three 2.4-mm locking screws (DePuy Synthes, West Chester, Pennsylvania, United States) proximally and distally were inserted manually at the level of the initial incisions. Screws number 1 to 3 measured 20 mm, screws 10 and 11 measured 18 mm, and screw 12 measured 16 mm in length, respectively. Incisions were apposed using 3-0 nylon in a simple interrupted pattern between screws (►Fig. 4A, B).

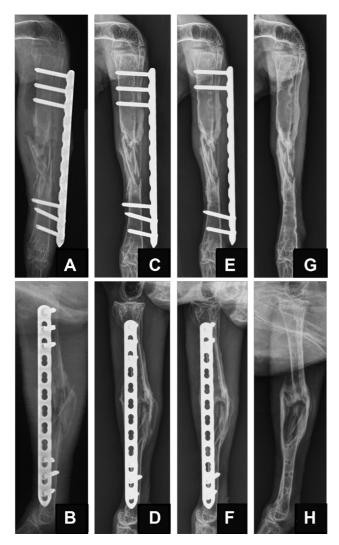
Fig. 4 Radiographs of the left tibiotarsus of a wild turkey vulture (*Cathartes aura*) immediately postoperative (**A**, **B**), at 4 weeks postoperative (**C**, **D**), at 6 weeks postoperative (**E**, **F**), and at 8 weeks postoperative (**G**, **H**).

At 4 weeks postoperatively, the turkey vulture was placed under general anaesthesia for radiographs. This set of radiographs confirmed evidence of hard callus formation expanding the fracture gap. In addition, loss of bone density was noted within the diaphysis proximal and distal to the fracture line (**-Fig. 4C, D**). While under general anaesthesia,

At 8 weeks postoperatively, a third set of radiographs under general anaesthesia confirmed continued fracture healing and increased cortical density (\succ Fig. 4G, H). At week nine, the turkey vulture was transitioned to an outdoor pre-release flight cage. This flight cage measured $30 \times 10 \times 15$ ft and has two tall posts with heights of 7 ft and perches of varying sizes that ascend its height. The vulture was monitored once daily and was observed to fly between the two high perches, land, grasp, walk, and perch normally. It was also noted that the turkey vulture could descend to the ground to feed, land normally, and return to the high perches afterward (\succ Fig. 5). The turkey vulture was released back into the wild 12 weeks postoperatively.
