### Leadshot: An Unusual Cause of Stent Occlusion

R. England, D. Martin

Dept. of Radiology, South Manchester University Hospitals,  
Manchester, United Kingdom

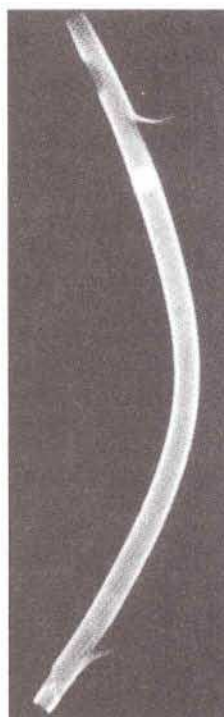
**Figure 2:** The stent was radiographed after removal from the patient, confirming the presence of an impacted piece of leadshot.

A 76-year-old man had inoperable carcinoma of the head of the pancreas that had been diagnosed three months previously, and had a 10-Fr, 7-cm Cotton-Leung biliary stent placed for palliation. He was well until two days prior to this admission, when he developed cholangitis. Endoscopic retrograde cholangiopancreatography (ERCP) was performed for presumed stent occlusion. At ERCP, the control radiograph showed a radiopaque foreign body, leadshot, projected over the proximal portion of the stent (Figure 1). On direct inspection of the duodenum, the stent was in a satisfactory position, but no bile was draining. The stent was successfully exchanged. The removed stent was radiographed after the procedure, and this showed that the leadshot was impacted in the lumen of the upper portion of the stent below the proximal side hole (Figure 2), causing complete stent occlusion.

The case presented here is, to our knowledge, the first report of stent occlusion by a biliary foreign body. The leadshot must have been ingested, and on questioning, the patient did admit to having eaten rabbit meat in the days prior to his presentation. More interesting is the mechanism of passage of the leadshot into the stent. It is known that placement of transpapillary stents results in enterobiliary reflux, but considerable duodenal pressure must have been achieved for the leadshot to lodge in the stent, resulting in occlusion.
