Coping in a calamity: Radiology during the cloudburst at Leh

Debraj Sen

Department of Radiodiagnosis, Asst Prof. (Radiodiagnosis), Command Hospital (CC), Lucknow, Uttar Pradesh, India

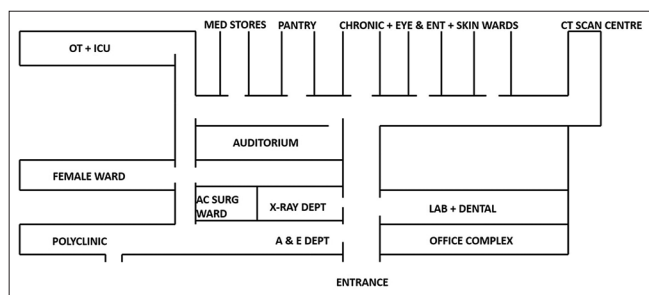
Figure 2: Line diagram showing the layout of the hospital. The CT scan center, radiography units, A and E Dept, and OT are at a considerable distance from each other

The distance between the Accident and Emergency (A and E) Department, operation theatres, surgical wards, and the radiology and CT wings was considerable (50 m) and valuable time was lost in transit [Figure 2] due to this design flaw. To avoid patient inconvenience and wastage of time, a portable ultrasound machine was stationed in the intensive care unit (ICU) to enable ultrasound examinations to be performed there itself.

It is important to have the Radiology Department with all its subsections like CT scan centre, Magnetic Resonance Imaging (MRI) centre, Digital Subtraction Angiography (DSA) lab as close to one another and to the Accident and Emergency Department and the Operation Theatres so that patients can be quickly triaged and sent for the appropriate medical imaging and subsequently for surgery if required. The department should have broad corridors to allow easy passage of trolleys and stretchers and large waiting areas to prevent crowding. Separate entrance and exits would allow unidirectional flow of patients and also prevent congestion and crowding.^[5] Being an equipment-heavy department, which is prone to damage due to dust, moisture, and water, the department should preferably be located on the first floor of a building to avoid the danger of flooding. Adequate provision for electrical power points, piped oxygen, and suction and devices for hanging infusion sets should be present.^[5]

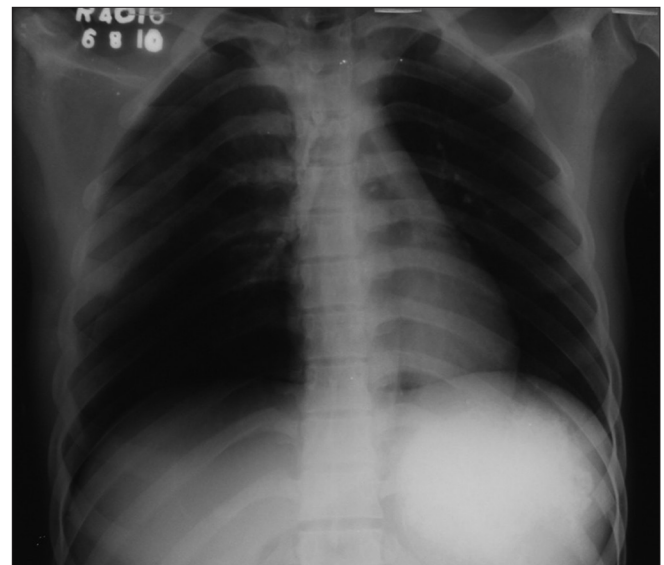
Figure 3: Radiograph Chest (PA view) showing aspirated mud outlining the trachea and bronchi (mud-bronchogram)

during non-emergency routines) in the form of fractures and aspiration of mud (mud-bronchogram) [Figure 3]. Intra-abdominal fluid was noted in four of the eight patients suspected to have abdominal trauma. Deep venous thrombosis of a lower limb was noted in one patient on color Doppler. Of the patients who underwent CT scans, 11 had skull fractures with signs of brain injury. Three patients had multiple vertebral and pelvic fractures. The presence of a radiologist during triage led to better decision making in terms of requirement of imaging for a particular patient, the modality that would best serve the purpose under the given circumstances, the urgency of imaging, and judicious and even usage of all available radiology resources. This contributed to a high yield of positive findings as is evident from Table 2. By helping reach a definite diagnosis and its severity, imaging was critical not only in deciding the appropriate course of action to be followed for a particular patient but also helped in the judicious and timely utilization of resources. Simple innovations like usage of serial numbers for all patients during initial documentation and imaging, pending confirmation of identity, helped obviate confusion and saved much valuable time. Other innovations like taking radiographs on the floor/stretchers obviated crowding within the department, excessive patient movement and reduced the requirement of manpower and increased patient through-put. Placing portable ultrasound machines and x-ray machines at critical areas apart from the radiology department also helped. Recruiting attendants and volunteers to help clean up the body parts and remove soiled clothing and also the radiography tables before imaging saved precious time and reduced distractions for the staff.
